One thing leads to another

25 April 2016

In the first in a series on the causes of damp, Mike Parrett looks at the connections between building design, failure and occupants' lifestyle

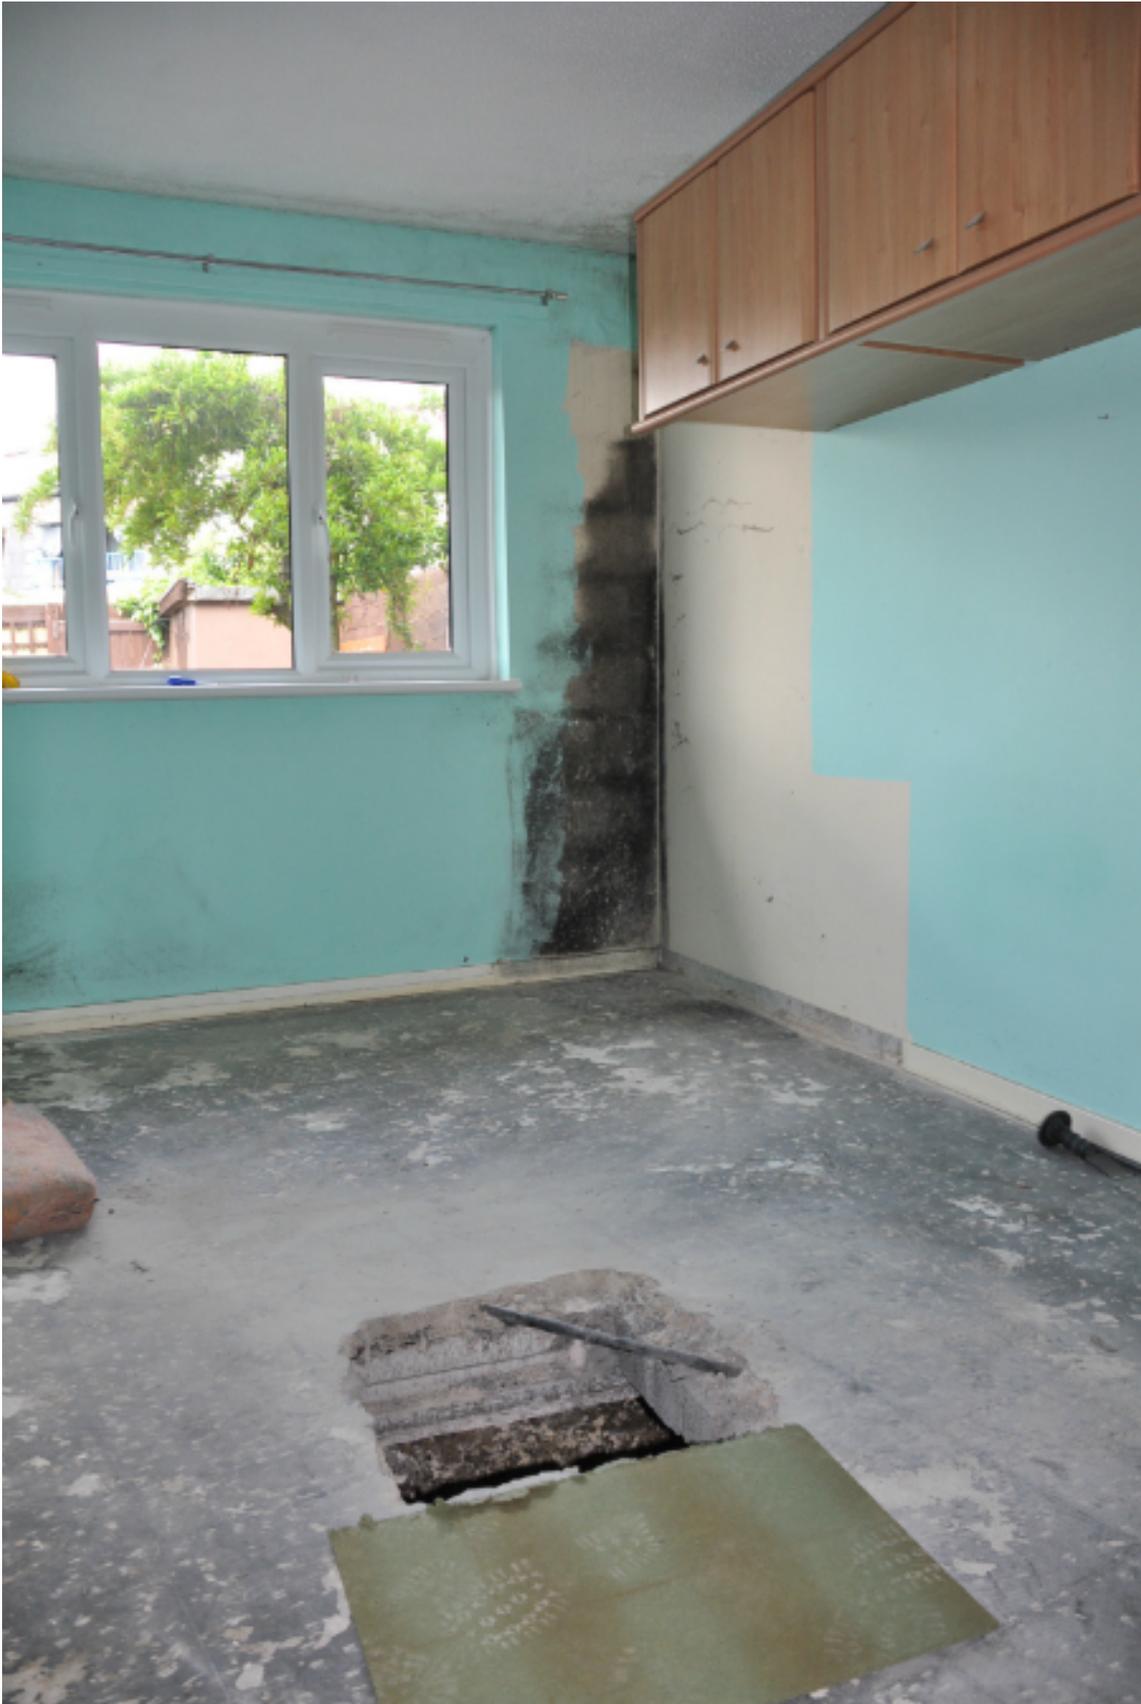
Figure 1: Black mould to external corner of party wall behind bedroom furniture. Mould also found at bottom of external wall. Level 1 or 2 surveys suggested use and occupation and/or penetrating damp (via high abutting external timber decking) was to blame. A Level 4 survey found construction and design issues were the main causes

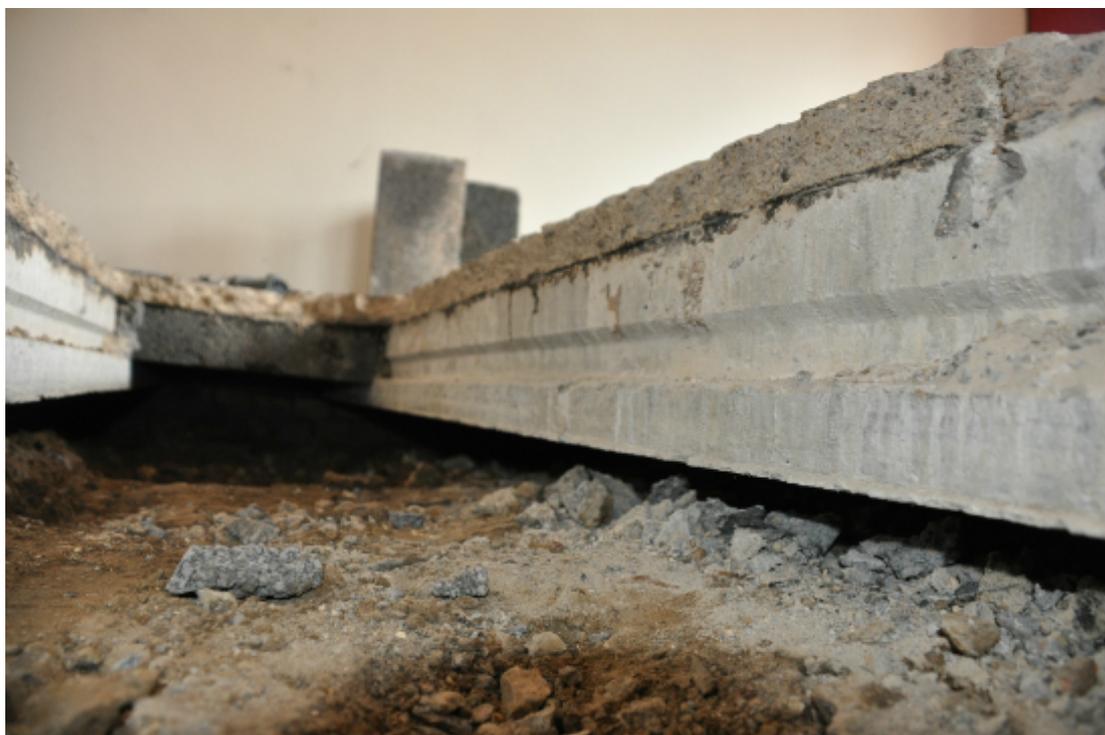
Figure 2: Opening a suspended (block and beam) solid floor revealed high rubble and arisings from original construction, in some areas in contact with the floor's underside.

No DPM to the oversite or vapour barrier to the floor (not a requirement in late 1970s/early 1980s properties on level sites)

An endoscope inspection found a deep sub-floor void. It contained builder's rubble and earth very close to the underside of the floor; this would become increasingly damp during rainfall as the ground became saturated. There were water droplets on the underside of the floor and no vapour barrier. The lack of air vents meant a build-up of water vapour and condensation that permeated into the habitable space.

The soil and rubble were removed, through-wall air vents installed to the external walls and a DPM installed. Internal mould was removed using a biocide and the flat redecorated and floors recovered. The problem of dampness and mould was resolved to the satisfaction of the occupiers and an out-of-court settlement reached.

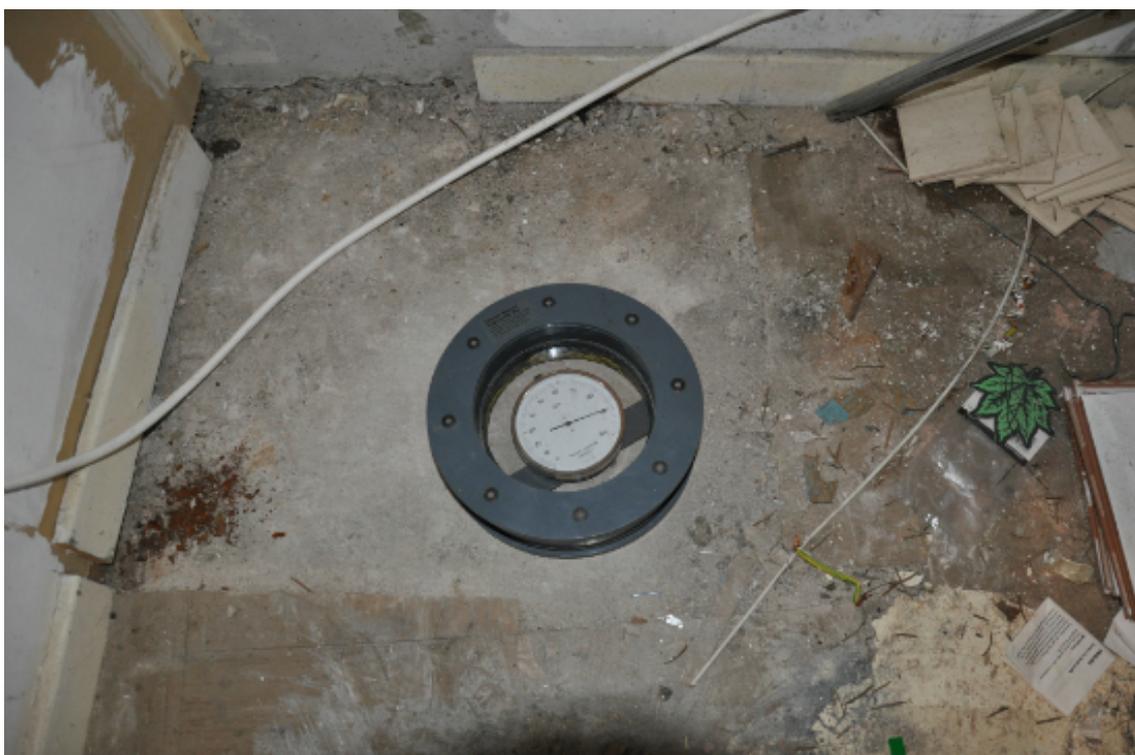
Figure 3: With evidence of distressed wood laminate flooring, a mechanical hair floor hygrometer was sealed to the exposed floor trapping a pocket of air, which stabilised at 90% relative humidity. As per BS 8203:2009, the solid floor was damp above the tolerable level (75%) for overlaying with floor coverings. Further investigation was

required (see figure 4)

The dwelling had a solid floor overlaid with wood laminate that had become distressed, indicating the presence of moisture. There were no external low-level through-wall air vents. Capacitance meter readings on the solid floor suggested dampness. A hygrometer was secured to the floor overnight. The next day, its relative humidity reading had risen from 60% to just over 90%. A solid floor should emit no more than 75% for it to be sufficiently dry to overlay with floor coverings. These measurements indicated a damp solid floor.

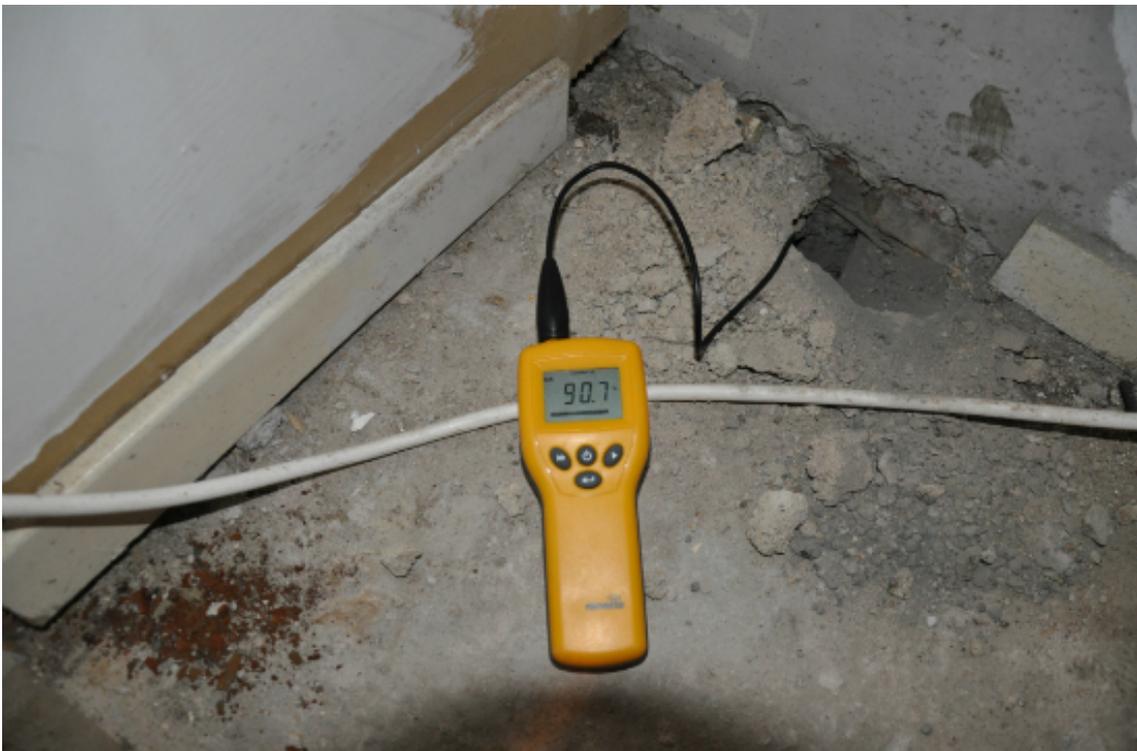
Figure 4: Floor section removed to look for a DPM. We found the solid floor was not ground-supported but suspended block and beam. A hygrometer probe was inserted to measure the moisture content of the sub-floor air, which was found to be 90.7% relative humidity and at equilibrium with moisture transfer through the floor. An optical endoscope examination confirmed significant rubble and arisings in contact with some sections of the floor

A small excavation in the floor to check for a DPM revealed it was actually a suspended solid floor. A hygrometer probe was inserted into the sub-floor void and left for 40 minutes. It also found just over 90% relative humidity, indicating that the dampness emanating from the suspended solid floor was at equilibrium with the sub-floor air.
