# Under the skin

8 January 2018

Trevor Rushton scrutinises the performance of cladding systems and the factors that can lead to failure

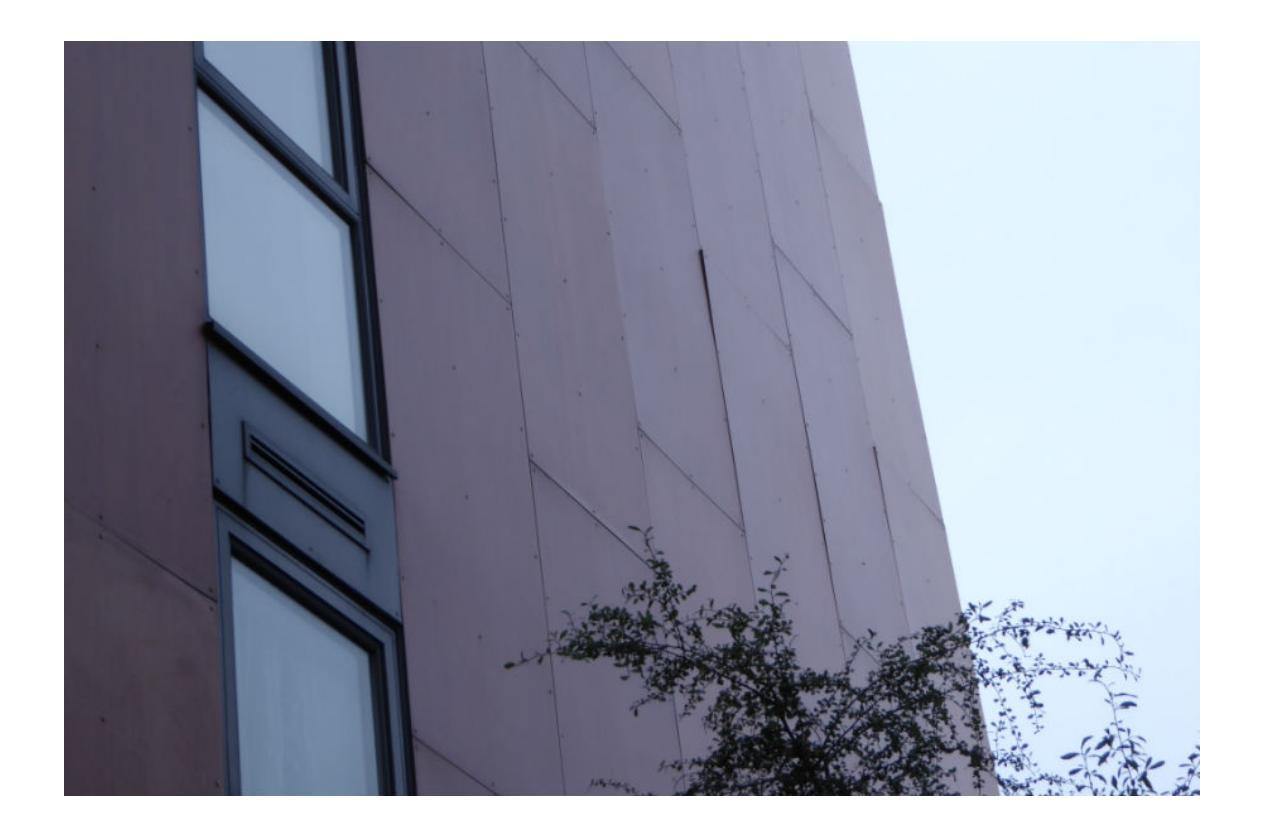
#### Figure 1: Distortions in an HPL cladding system resulting from incorrect fixing

A common method is to use rivet fixing, in which a central, fixed point carries gravitational loads while perimeter fixings restrict movement in the wind; the perimeter fixings must, however, permit the panel to move as a result of thermal and moisture changes, otherwise there is a risk of distortion, which will damage them or pull them out.

- rivet shank diameter is 5mm;
- rivet head diameter is 16mm;
- fixed-point hole diameter is 5.1mm;
- hole diameter for sliding points in the panel is 10mm;
- the rivet head should be 0.3mm free from the panel surface;
- rivets must always be centred in the holes;
- to retain their position, each panel must have one fixed point in the centre; and
- all other fixing points are sliding points.

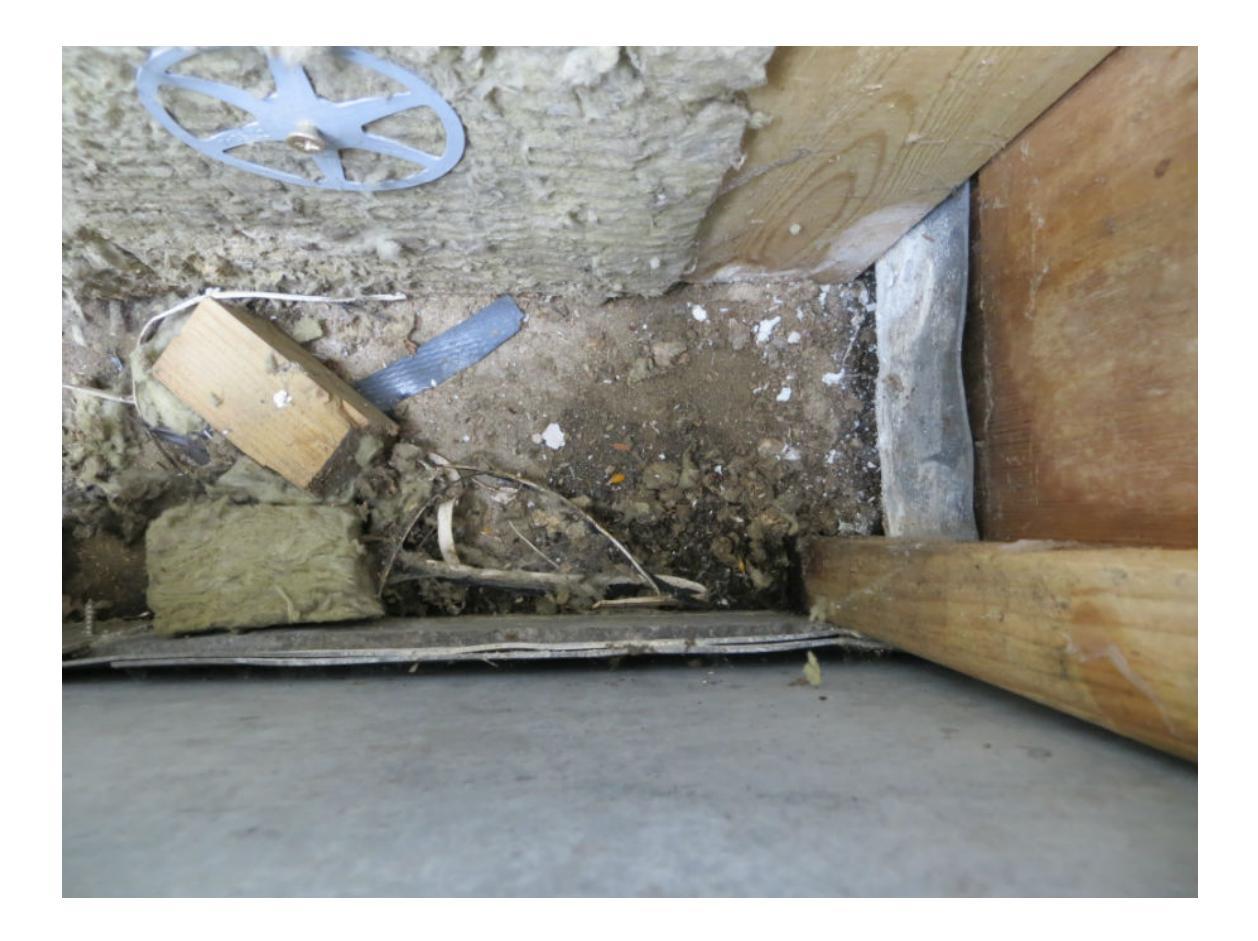
Figure 2: Cavity behind a timber rainscreen ? no provision for drainage resulted in significant water ingress internally
