# Nothing lasts forever

**Continuing his series on the connections between building design, failure and occupants' lifestyle, Michael Parrett considers how building defects contribute to damp problems**

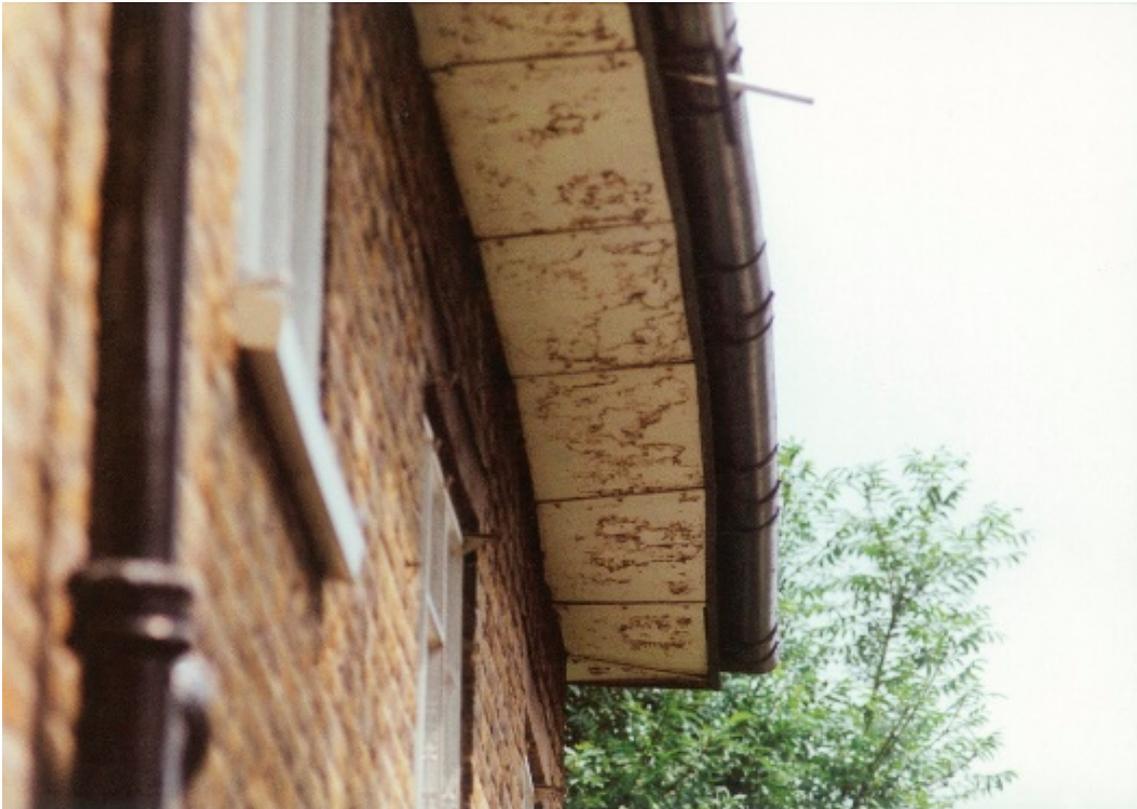
**Figure 1: Roof spread on a typical 1920s cottage where the original slate-tiled roof was**

replaced with interlocking concrete tiles with a much higher implied weight loading on to the frame. The timber collars had not been strengthened with additional bolts to the rafters. Warning signs include separation of the soffit boards from the wall face, curvature of the cast iron guttering and outward movement of the top of the brick walls.

Poor construction often exacerbates deterioration and increases the chance of building failures. Take the example of a slate roof that has naturally deteriorated and needs renewing. Slate roofs should normally be replaced with a similar natural or simulated material, but interlocking concrete tiles are often used and these place a much higher loading on to a timber-framed roof, so additional strengthening works are needed.

We have found cases where this has not happened and even instances where some collars, struts and purlins have been removed, or the collars are merely nailed rather than bolted to the rafters. These issues lead to roof spread that pushes out the tops of the external walls, distorting soffits and fascia boards and even bending cast-iron gutters. In extreme cases the roof can collapse.

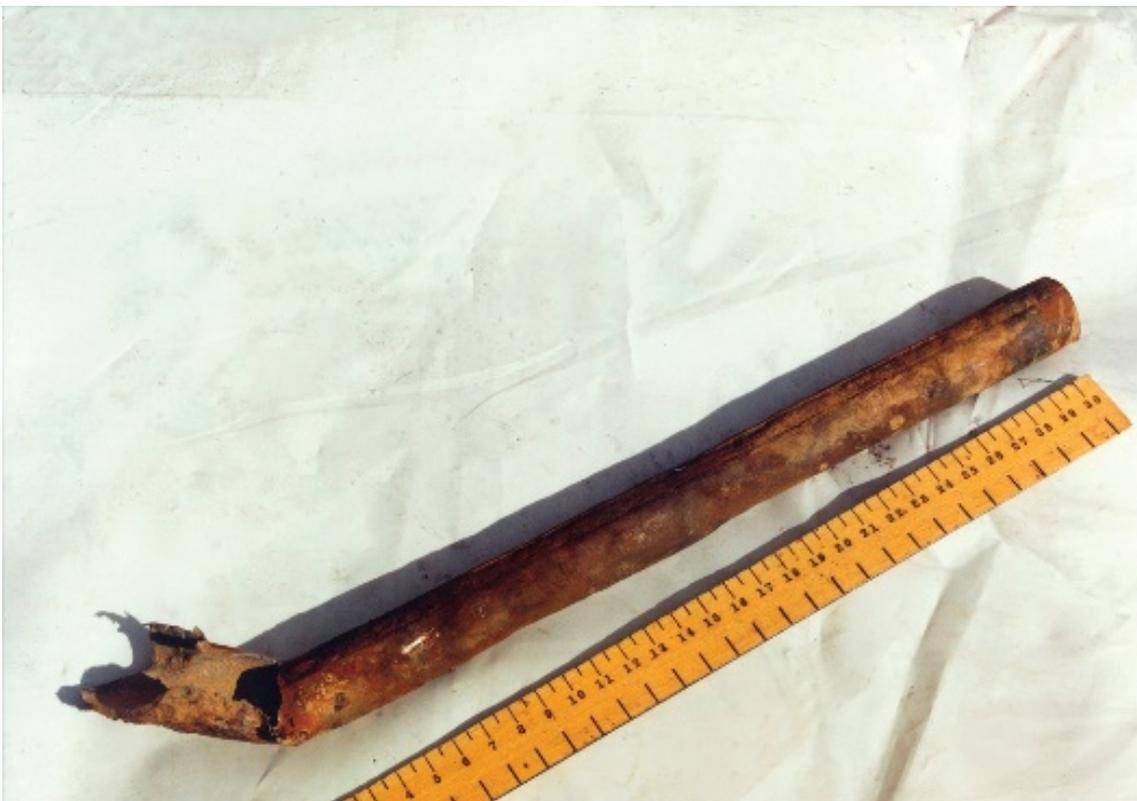
**Figure 2: Perforation of steel barrel underground water main supply pipes. Galvanised (zinc-coated) steel pipes laid into soil will eventually corrode and lead to an escape of water. These pipes were excavated from the ground at an 85-year-old property. Zinc is a sacrificial anode and will deteriorate in most soils, especially ones with higher acidity. This results in the steel gradually losing its protection, leading to corrosion and eventual perforation of the buried bare steel pipes.**

Underground lead water mains meanwhile have a proven life of around 100 years, after which they become brittle and the slightest movement will cause them to perforate or fracture, particularly if they are laid in acidic or aggressive soils. Natural deterioration also happens with underground steel pipes for gas and water mains. Some are galvanised and use zinc as a sacrificial anode that will deteriorate; a similar process is used on old steel-frame windows. In both cases, the zinc breaks down and exposes the unprotected steel beneath, which then rapidly corrodes.

For example, flat roofs with elastomeric mineral felt systems only have an insured life of 20-25 years, but many may not last that long. A protected underground steel water main may last 50-80 years, but an unprotected one may perforate in eight to 10 years. It is important that somebody understands this lifecycle information as it allows them to make proactive and informed decisions about maintenance work.

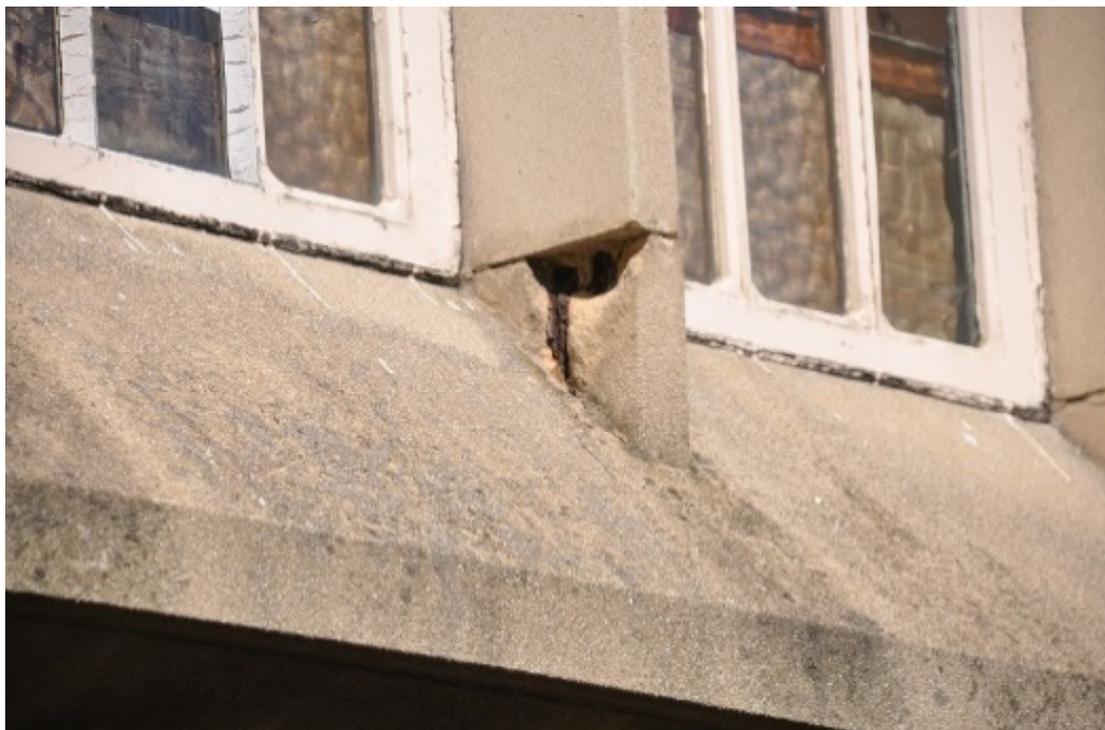
**Figure 3: Carbonation of reinforced concrete mullions on a 1960s building. Some buildings with reinforced steel concrete can benefit from additional cathodic protection, which can act as a medium to take the corrosive electrical flow away from the embedded steel rebars in damp concrete.**

- carbonation of concrete, when carbon dioxide slowly penetrates the surface and mixes with moisture trapped in the pores, reacting with calcium hydroxide to form calcium carbonate that causes the deterioration of the concrete and the steel reinforcements inside

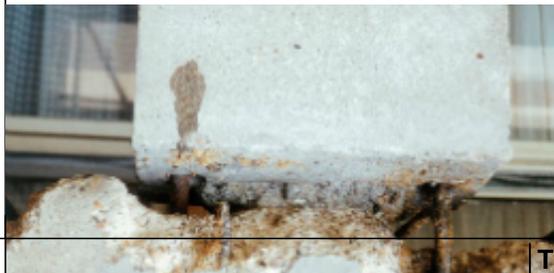
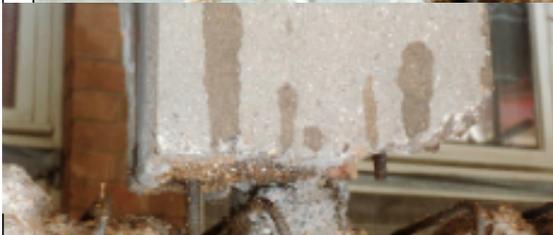
**Figure 4: Carbonation of concrete, as seen in both images, occurs when reinforced concrete absorbs moisture and carbon dioxide from the air. This reacts with the Portland cement, which contains calcium hydroxide, and begins to lower the alkalinity of the concrete from the normal level of around pH 12.**

**The acidity then increases and begins to corrode the steel reinforcements at pH 7 or below. The deterioration weakens the structure, eventually requiring specialist repair. The carbonation process is only harmful in reinforced concrete and will not occur in very dry environments (below 40% relative humidity).**
