Stack it up

Chimneys in older buildings need careful attention and upkeep to maintain building fabric and avoid the risk of fire, as the first of two articles on the subject details

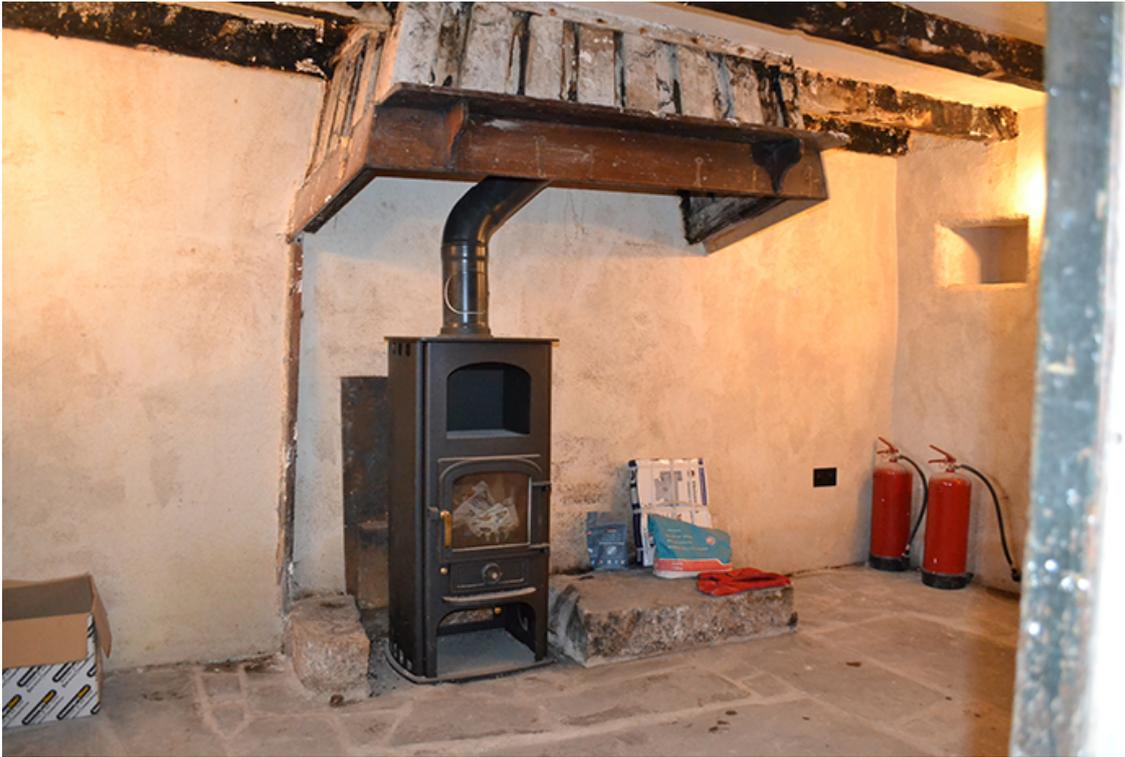
Figure 1: A 'hanging lum' dating from the early 19th century at a croft house in the north of Scotland

Chimneys were rare in the early Middle Ages, but by 1400 most homes in Europe had a hearth and chimney as we would recognise them today. It is likely that vernacular building techniques copied the early masonry hoods, and successfully used lower-cost materials to form hearths and flues. In some parts of Britain and Europe these traditions continued; in Scotland the 'hanging lum', formed of timber yet redolent of its medieval ancestor, was in use until the early 20th century. A good example is the timber hood and chimney in the parlour of a croft house near Braemar in the north of Scotland (see Figure 1).

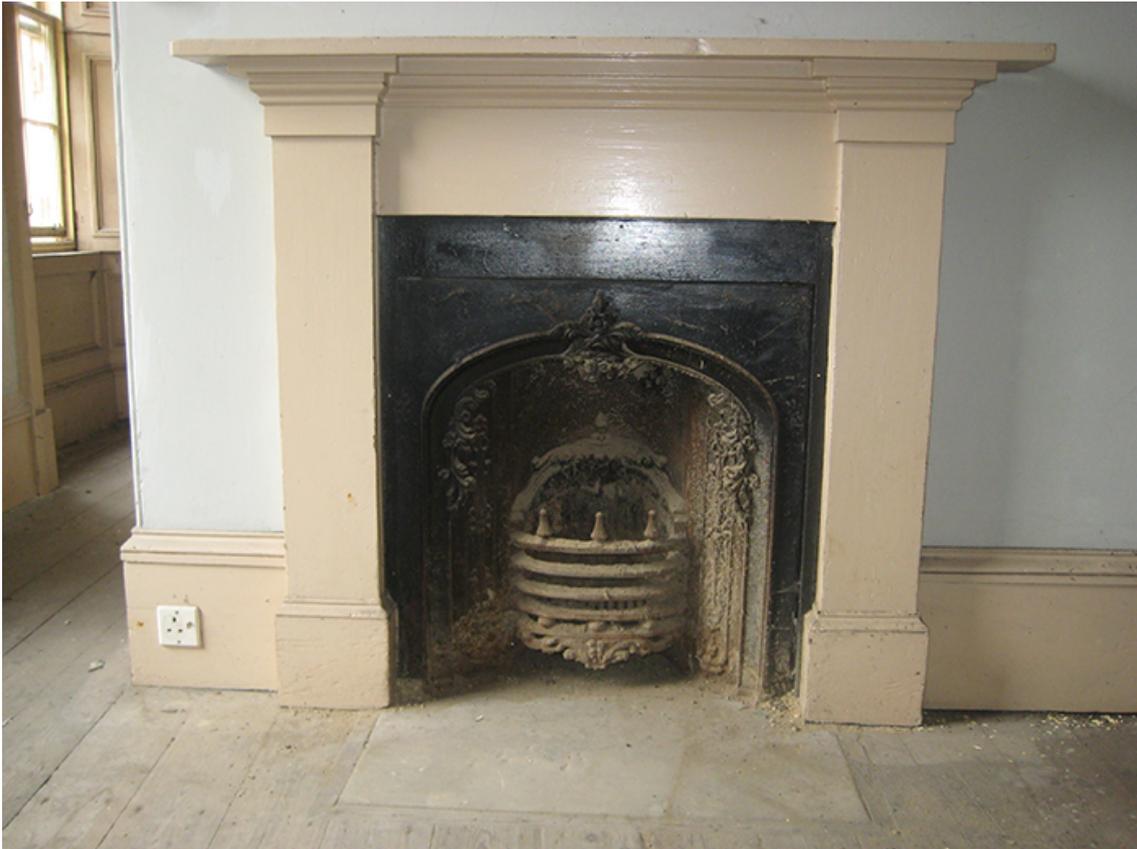
Figure 2: A Victorian cast-iron grate for burning coal

Masonry flues, by being routed up through a building, represented a large quantity of stone that had considerable thermal mass, keeping the centre of the building warm and at a steady temperature. As fuel types changed, generally favouring increasingly intense sources such as coal, this resulted in smaller hearths, often with cast-iron grates. Figure 2 shows an image of one such dating from around 1840.

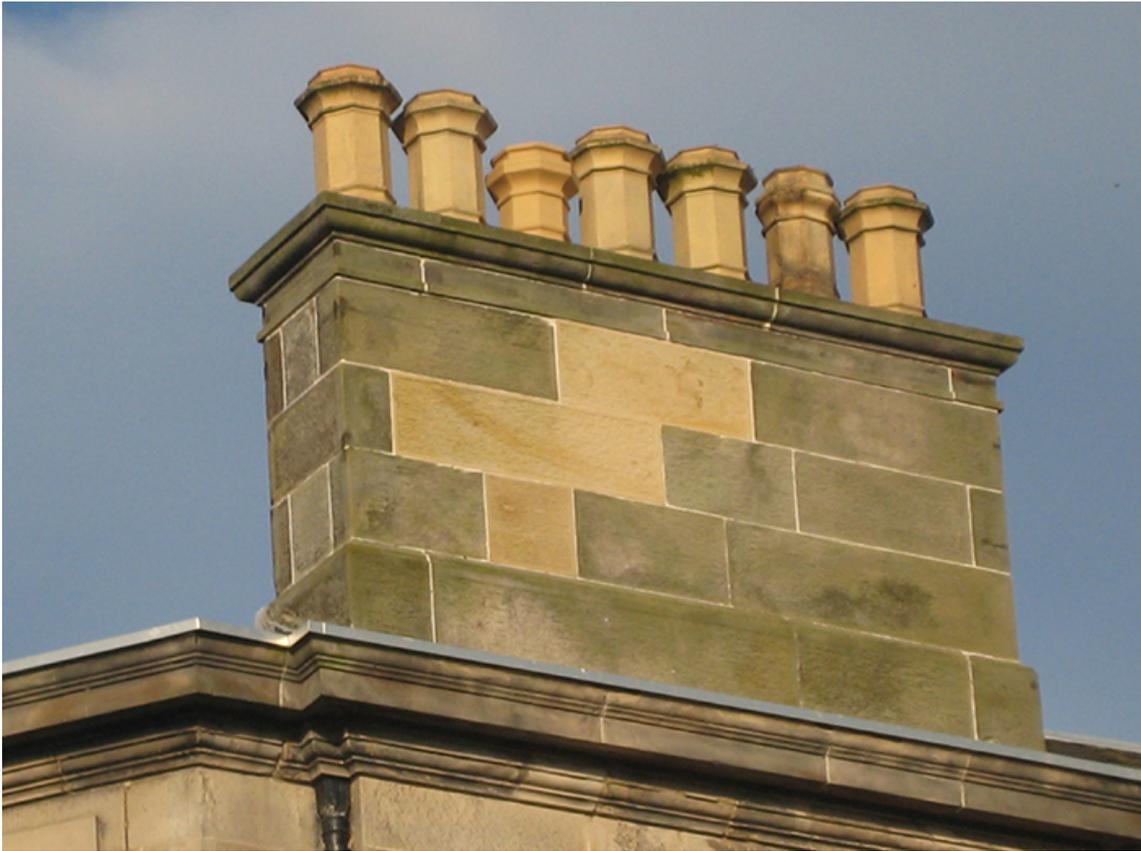
Figure 3: A traditional stack in Edinburgh showing chimney cans and the ashlar masonry work

Most flues were given a layer of plaster internally so there would be a smooth flow of smoke and all gaps were filled; this is a feature called parging. The top of a chimney stack would then be finished with a stone covering, often called a chimney cope; while changing architectural styles give different shapes and finishes to this feature, its overall aim is to ensure water is shed from the chimney top (see Figure 3).

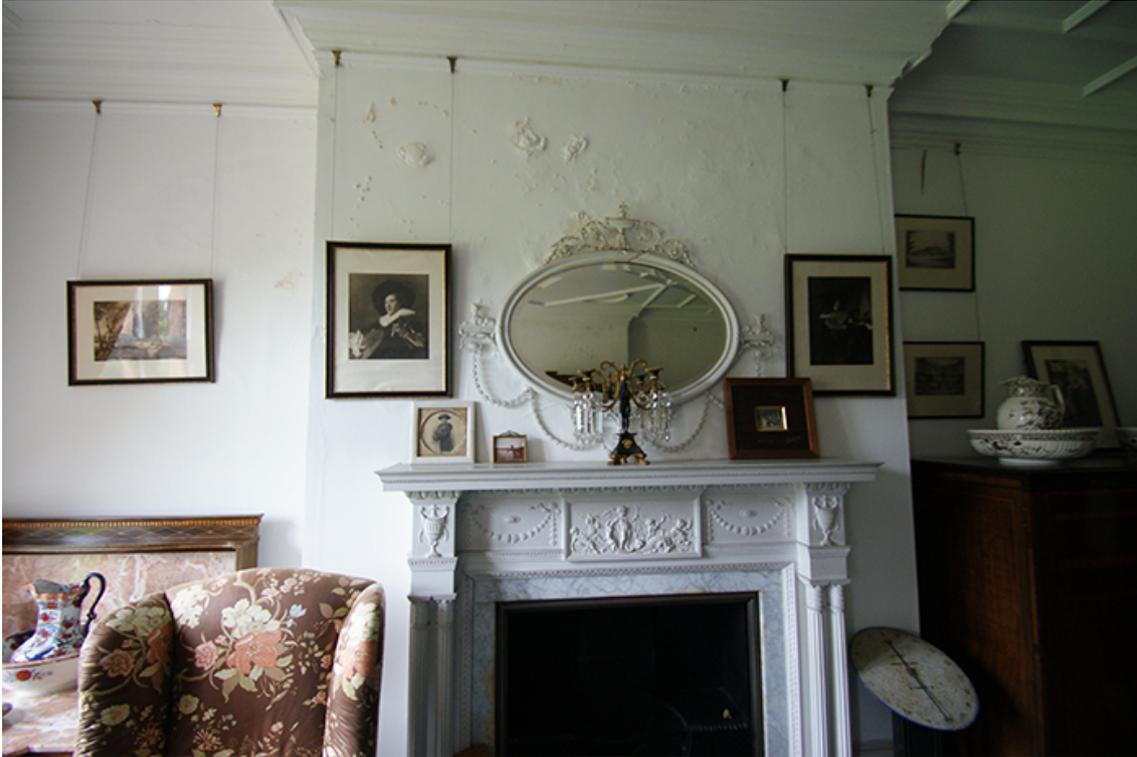
Figure 4: Water ingress in the chimney above is showing lower down through blistering paint and staining

In serious cases, the tar and combustion deposits in the chimney are mobilised by water and seep through the plaster lower down, discolouring it and blistering the paint (see Figure 4). Such deposits, usually termed sulphates, can lead to the formation of sulphuric acid, which damages cement-based mortars due to expansion of the binder and aluminates in the ordinary Portland cement. Some forms of early engineering brick are also damaged this way, although lime mortars are less affected given their lower aluminium content.

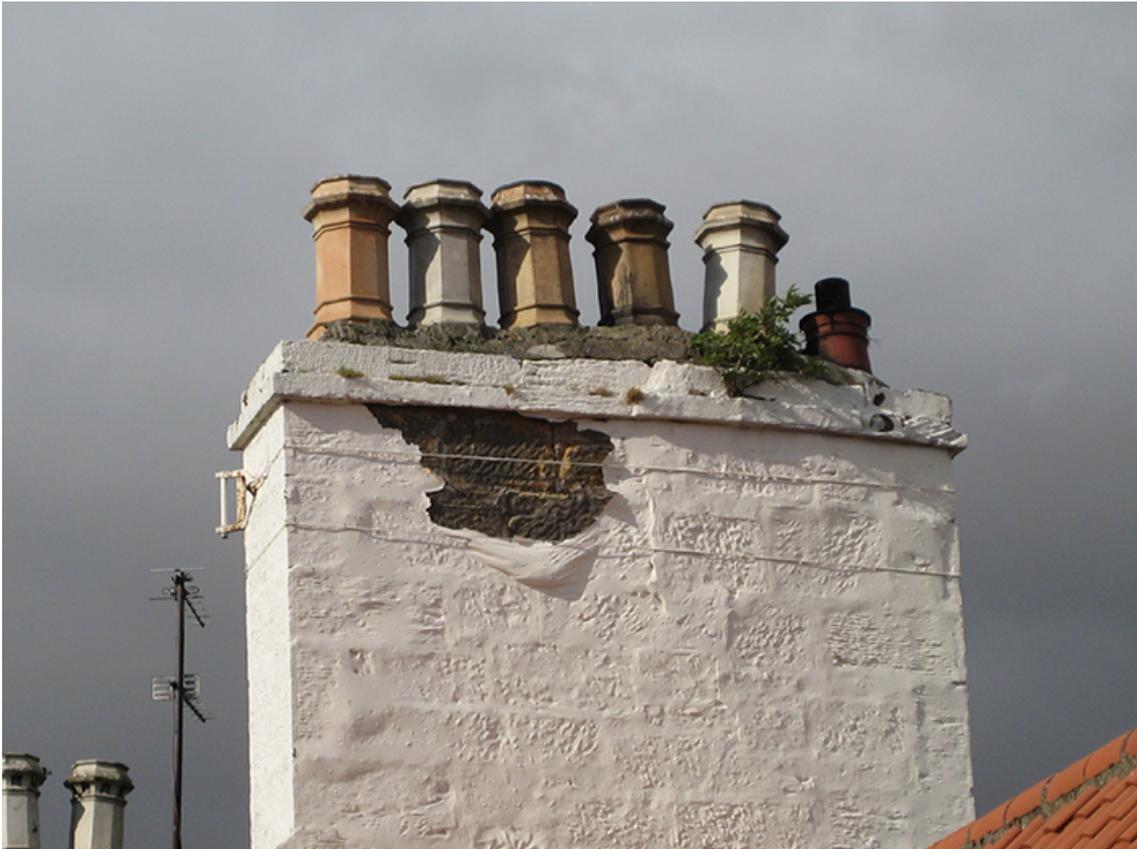
Figure 5: A traditional chimney in poor condition. Note the plant growth and the paint blistering as it is thrown from the stone surface

Figure 5 shows a chimney in poor condition, with all the above defects in evidence. It is likely that internal masonry such as bridges and linings is also damaged and clear that impermeable masonry paint has been used in an attempt to keep water out. As the masonry defects have not been addressed, this inappropriate remedial treatment is simply retaining water, accelerating damage, and paint peels away. A well-maintained chimney, inspected and repaired at regular intervals, will not need such a damaging measure.

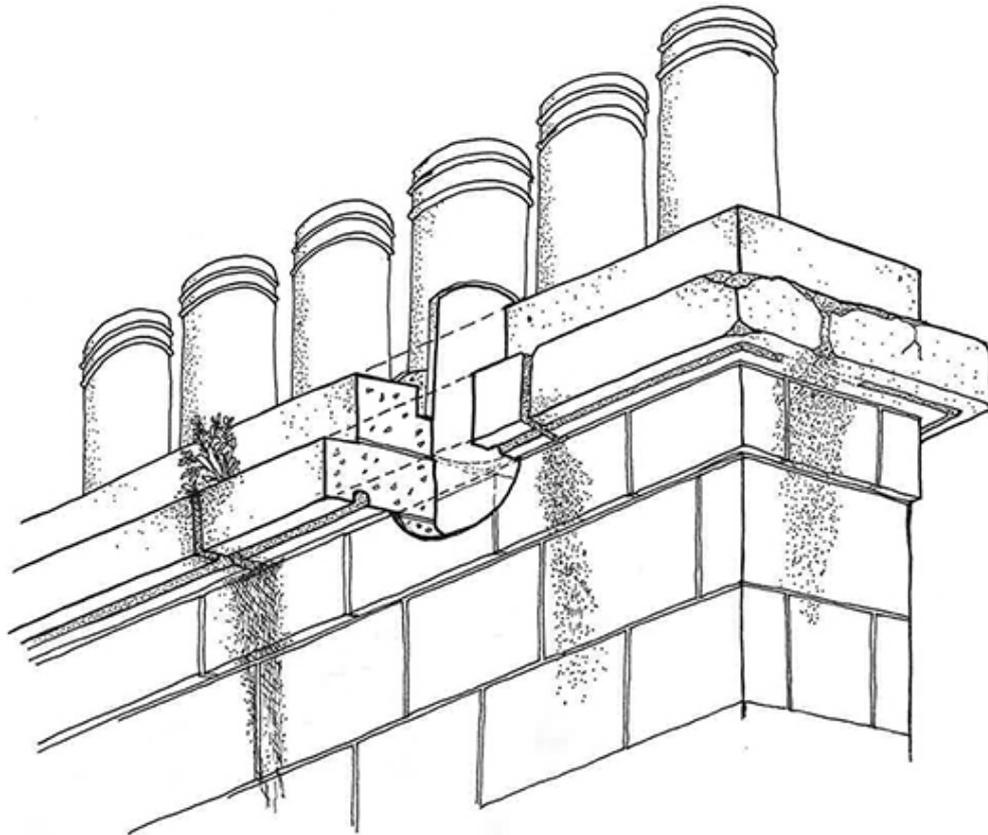
Figure 6: Drawing showing typical external defects in a chimney. Note the loss of water-shedding capacity due to the damaged cope

Even a well-maintained chimney will be subject to accelerated deterioration if it is not designed to suit its immediate environment. In the often-damp climate of the UK, this means the chimney cope should be designed and detailed to shed water clear of the masonry below. If this is not done, then water continually runs down the chimney face, eventually leading to the failure of pointing, stone or other materials. Some architectural styles give a good cope or cornice, others less so. The illustration above shows a traditional chimney that is well designed and detailed, but with damage to the cornice, missing pointing and plant growth that will all lead to dampness and stone decay.
