Effective or defective?

Surveyors should be on the look-out for fire-related defects to ensure that buildings comply with regulation revised following the Grenfell Tower fire

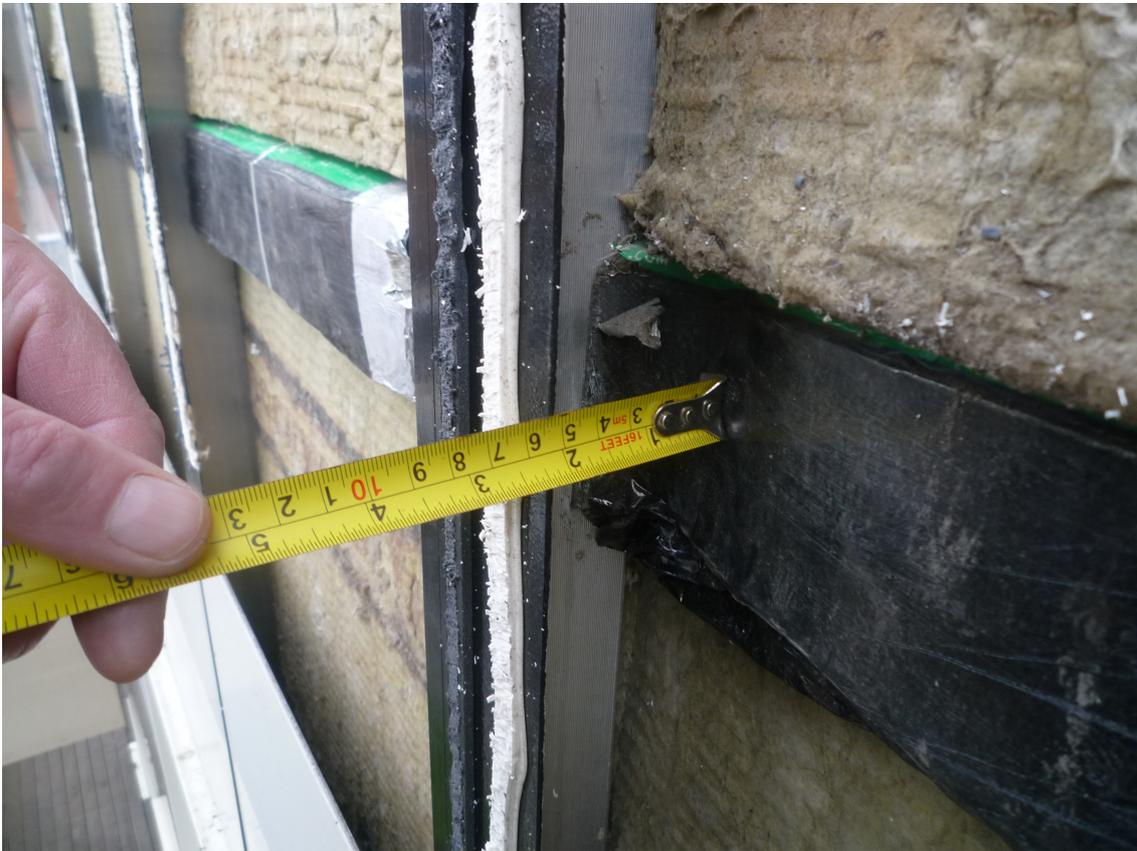
If such barriers are not secured properly, they will detach, sag or deform, rendering them incapable of performing their function. Following 1 intrusive inspection, the maximum allowable gap for the intumescent strip on a mineral wool cavity barrier is marked clearly on the product as being limited to 25mm. However, the cavity barrier air gaps were found to be up to 80mm, so would be unable to close off the cavity in the event of a fire. The photo below shows indiscriminate installation of cavity barriers that are totally ineffective in the event of a fire.

Figure 1: Indifferent and excessive installation of cavity barriers

Apart from combustible cladding materials, the construction behind rainscreen cladding is largely unseen and can be a huge concern in terms of fire risk. The void or cavity formed in rainscreen systems is susceptible to propagation of fire by the chimney effect. It is therefore imperative that effective measures be taken to contain the spread of fire in the cavity: defective installation can mean that closers will not form a compartment in the event of a fire, and their ability to contain it is then completely lost. Cavity barriers must be fitted so they remain in place securely throughout the life of the construction while allowing ventilation of the cavity. However, they must close off the cavity as it intumesces when exposed to fire, thus starving the space of oxygen.
