# What?s going on here?

In his latest article on damp in buildings, Michael Parrett looks at the problems caused by blockages under suspended floors and external through-wall air vents

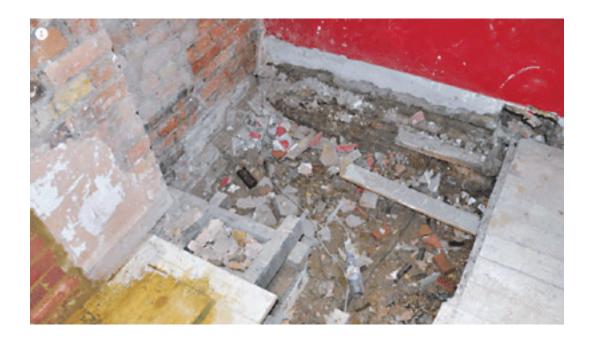
Figure 1: General builder?s rubble and arisings placed under the timber suspended floor following property refurbishments

If rubble and arisings are very close to the joists or boards in timber suspended floors, then often dampness will wick through this waste material. This will introduce moisture directly into the timber elements, eventually leading to wet rot(in well-ventilated subfloors) or dry rot (where ventilation has been reduced). This problem can also be caused by blocked external vents. If there are lead water mains under timber suspended floors, any leaks may soak into rubble and arisings, increasing the humidity in the subfloor void.

Rubble and arisings may be piled up against external and intercessionary walls running upwards through the floor above. This can bridge the damp proof course from the inside and may provide all the symptoms of rising damp, potentially resulting in the incorrect recommendation for a retrofit chemical injection. Fire hearths, particularly from the 1800s to the Edwardian era, may also intercede floors. The supporting fender walls may be seen by looking underneath a timber suspended floor. Often these do not contain a physical horizontal damp proof course and the core may be filled with earth and gravel. If the fire hearth and its fender walls are surrounded by rubble and arisings, they act like a wick to take moisture up into the chimney breast and its reveals.

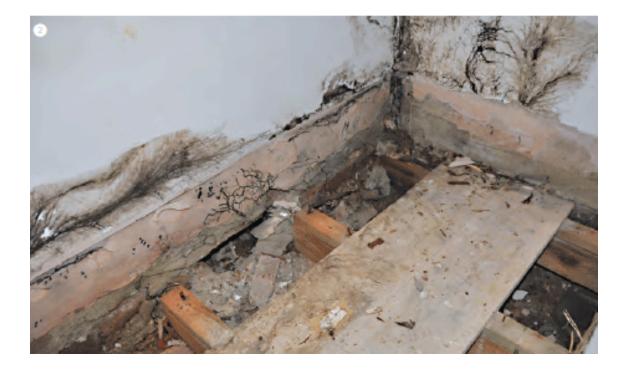
Figure 2: Blocked external low level through-wall vents to the sub-floor. The resultant increased moisture activity led to an outbreak of the dry rot fungus *serpula lacrymans*

Where air vents do not exist or are blocked around the perimeter walls, the moisture content of the air below the suspended floor can increase. This crucial issue is often not commented on during surveys.

The physical horizontal damp proof course in the walls should always be below the internal finished timber or solid suspended floor. Through-wall air vents are typically just below the physical horizontal damp proof course. Of course, if the external ground levels are either partially or fully covering those vents, then the physical horizontal damp proof course could be bridged.

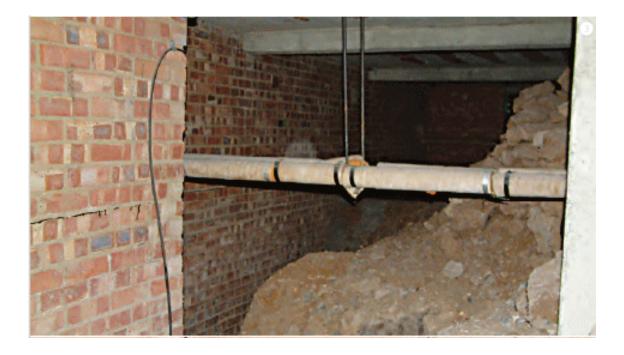
Figure 3: Deep void below a solid suspended floor full of earth and rubble that needed excavation to remove the threat of excessive dampness and resultant condensation. Water droplets were found to the underside of the solid floor, which did not have an impermeable vapour barrier

We surveyed a 1970s, two-storey block of flats in Surrey, with one- and two-bedroom ground and first-floor properties and a communal entrance hall. There was evidence of chronic condensation, i.e. black mould around windows, on external wall surfaces, ceilings, within cupboards and even on partition walls. There were significant amounts of material under the suspended floors that eventually filled three 2.75m skips from below a two-bedroom ground-floor apartment.

A cavernous void underneath the flat was full of material, requiring the whole of the block and beam floor to be removed for access. A hygrometer used on and below the floor indicated a 94% relative humidity at both points, indicating moisture equilibrium.

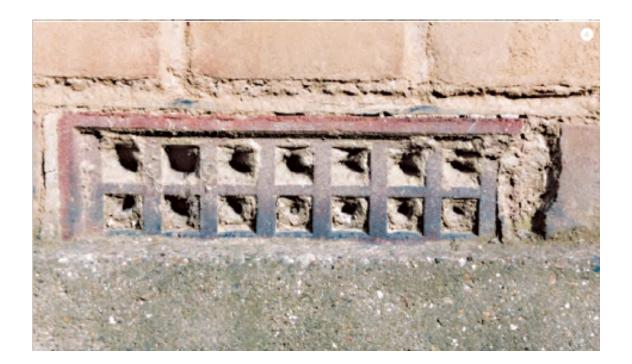
Blocked low level through-wall air vent. The physical damp proof course is just above the vent. The abutting solid concrete patio is in contact with the bottom edge of the vent, sufficient for rainwater to penetrate through the air grill. Rain splash from the hard external surface will introduce dampness into the solid masonry wall above the height of the horizontal damp proof course

Raised ground levels around air vents can give rainwater an easy route into the subfloor area, especially during heavy rain or flooding. Often, particularly with solid suspended floors, periscopic vents are used where the outside vent grill is higher than the air vent underneath the suspended floor.

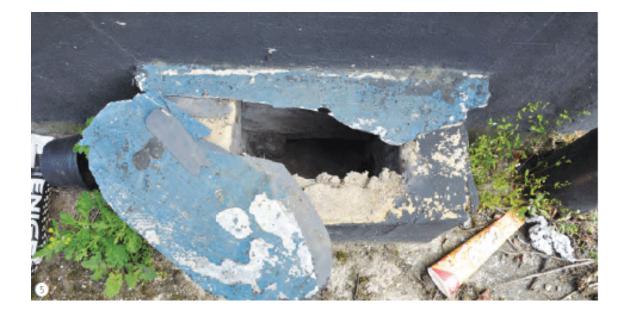
The low level through-wall air vent was shrouded with a half brick thick wall because the external ground level is far too high above the location of the air vent. A slate had been placed over the top of the brickwork to prevent rainwater induction. Another vent to the outer brick created a periscopic ventilation system. The failed slate top resulted in substantial rain water penetration through to the internal suspended timber floor

We have found instances where someone has cut into the solid masonry wall to insert a periscopic vent because it has been difficult to lower the ground levels. This may mean that the original ground level is still bridging the physical horizontal damp proof course. Where those air vents have been chopped into the wall, they may have cut through the physical horizontal damp proof course.

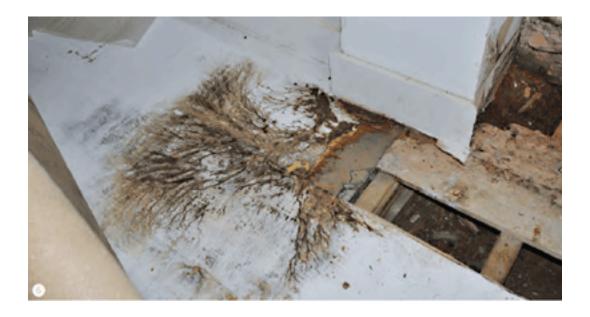
Timber suspended floor and solid fire hearth that had also been over-boarded with timber plywood panels. The dry rot outbreak was due to high abutting ground levels, which had blocked the low level through-wall air vents, and low level dampness penetration through the solid external walls; the sub-floor void was very shallow and a high water table also helped produce the ideal environment

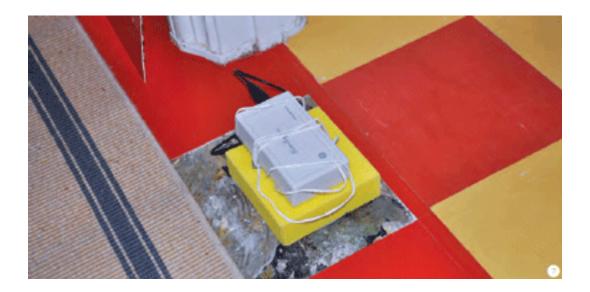
Purpose-made humidity box, sealed to the solid ground supported floor with hygrometer and temperature probe connected to a data capture device to measure the moisture profile of the solid floor (independent of the atmospheric conditions of the habitable rooms)

Often called ?block and beam? suspended solid floors, these are usually constructed of prestressed inverted concrete T beams infilled with concrete blocks and screeded over. These are more difficult to test for moisture than timber, but an easy way is with a hygrometer inserted into a purpose-made humidity box and sealed to the floor. This traps a pocket of air under the box and ideally measurements are taken over 7 days or so to produce a moisture profile.

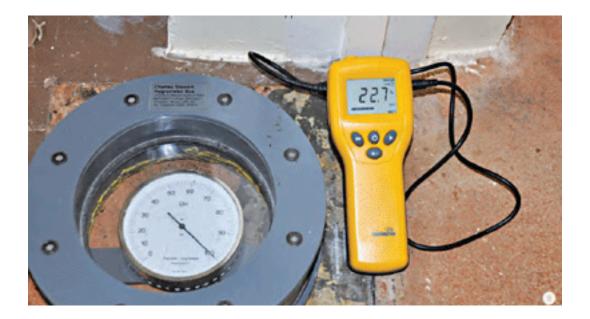
A mechanical hair hygrometer sealed to a solid ground supported solid floor after removing a single thermoplastic floor tile. The hygrometer rapidly recorded 100% relative humidity indicating that the solid floor was damp. This explained the timber damp reading of 22.7% to the bottom of the door lining (above the level at which timber will decay)

An electrical resistance meter can be used to check for moisture activity by measuring the bottom of the timber door linings (unlike skirting boards, they rarely get changed). This would indicate moisture in the subfloor void or the wall to which the door lining is attached. An understairs cupboard can be a good place to view the original timber suspended floor because it may not have any floor coverings. It might even be possible to lift a floor board or drill a hole and view the subfloor void using an endoscope.
