Don't be afraid to ask

Continuing his series on the connections between building design, failure and occupants' lifestyle, Michael Parrett considers how poor design contributes to damp problems

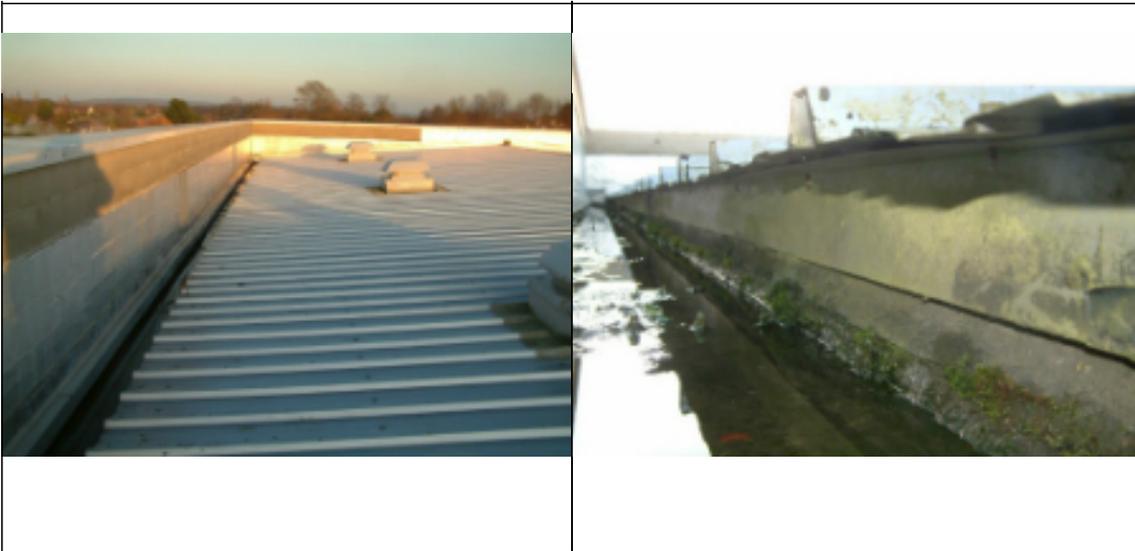
Figure 1: Roof drainage. Shallow corrugated perimeter parapet walls. Little allowance for downpipes

Figure 2: Gutter through high walls water flows towards eaves. Parapet to the eaves too shallow. Roof suffered from algae growth, leaf litter and airborne detritus. Together with chartered regional rainfall averages, the drainage system was deemed hydraulically short.

I know of an example of poor drainage design on a college building with a shallow-pitched, lightweight metal roof to save cost, surrounded by a very high brick parapet wall. There was a linear box gutter on each side of the roof for displaced rainwater, with six pipes and hopper connections.

During heavy rainfall, the gutters filled with water, which rose above the edge of the roof slopes at the eaves and was pushed up underneath the corrugated roofing and into the building. Initially, the problems were thought to be because of detritus and physical obstructions to the gutters and outlets through the parapet walls and collecting hoppers.

We found a problem when we assessed the building holistically; we looked at the roof area, pitch, parapet wall height, gully/outlet/hopper size, rainwater downpipe diameter, rainwater bounce off the inside of the parapet walls and the official rainfall intensity for the region (detailed in BS EN12056 Part 3:2000). When the whole design was subjected to a proper drainage calculation, it was found to be hydraulically short, i.e. unable to disperse water fast enough during heavy or prolonged periods of rainfall.

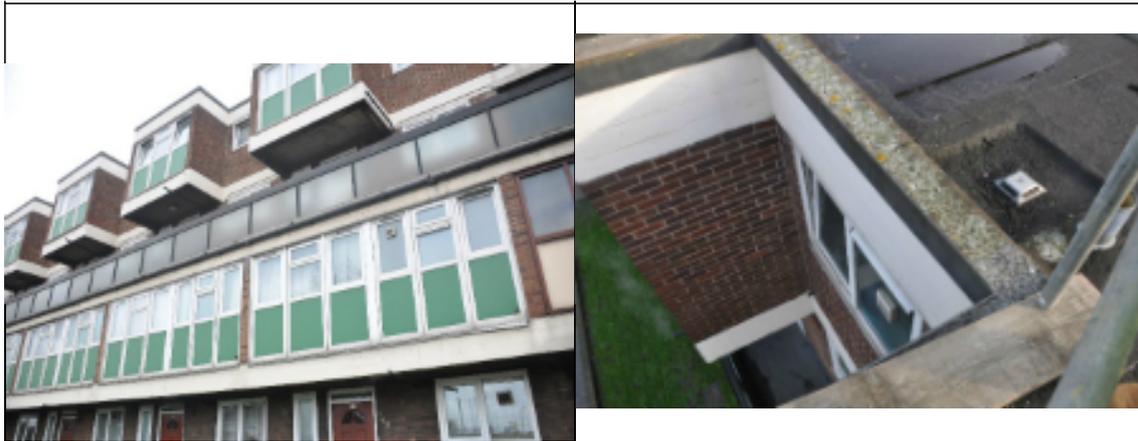
Figure 6: Upper box-bedroom projections lacked any insulation to the flat roof above, exposed floor slab below or side cavity walls. Internal conditions worsened when fenestration was changed to PVCu double glazing, as this helped retain heat but also had doors have partially exposed solid floors and ceilings neither had any original insulation.

But that push to create extra space created real problems. The projection normally consisted of part of the bedroom floor slab exposed over the walkway and two side walls, which were partly external because they extended from the building line. The front wall would, in some cases, also include a full-height window frame or possibly low-level timber or replacement PVC infilled panels. Add a top floor with its uninsulated flat roof (Building Regulations were not introduced until 1965) and it is a very thermally inefficient design.

Flat roofs and their abutment with parapet walls and around drainage outlets are probably most vulnerable to water penetration. The projecting rooms have enormous problems of cold bridging and resultant condensation, including the phenomenon known as interstitial condensation. This is where the dew point temperature is reached within the building mass so condensate drips out of the structure, and is often misdiagnosed as rainwater penetration. Thermal bridging has been an issue in the design of different types of buildings over the past 100 years or so.
