A retail breakthrough

Building control surveyors had a significant role to play when it came to coordinating construction and ensuring safety in the extension of the Westfield shopping centre in Shepherd's Bush

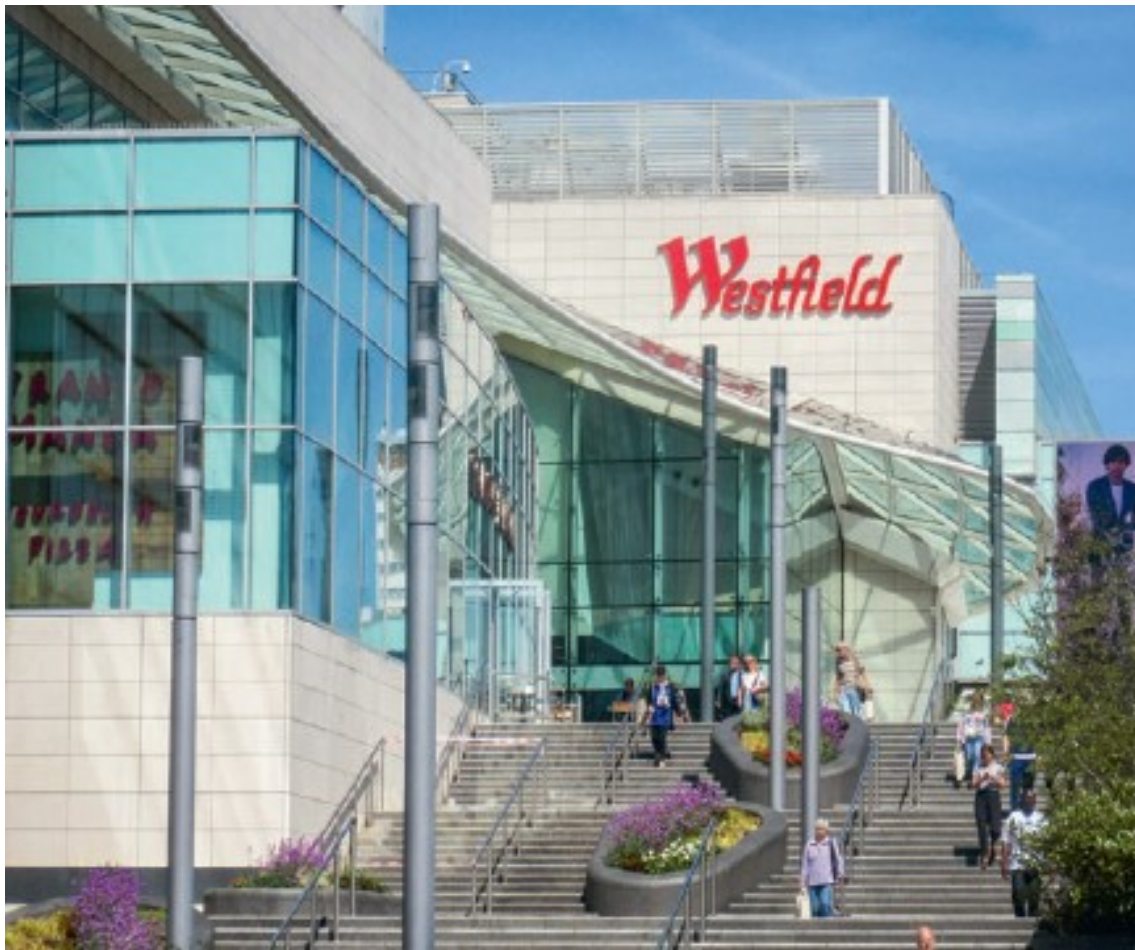
Figure 1: Westfield, Shepherd's Bush: works to extend the shopping centre had to be kept separate from the existing structure

was also subject to all relevant health and safety legislation until work was completed. It was crucial that the centre's management was aware of any works that were likely to affect the fire strategy so this could be updated accordingly. The construction site was separated from the public mall by a 60-minute fire-resistant hoarding.

It was essential that the areas of construction were separated from the existing mall while works were carried out
