What's going on here?

In his latest article on damp in buildings, Michael Parrett looks at the problems caused by blockages under suspended floors and external through-wall air vents

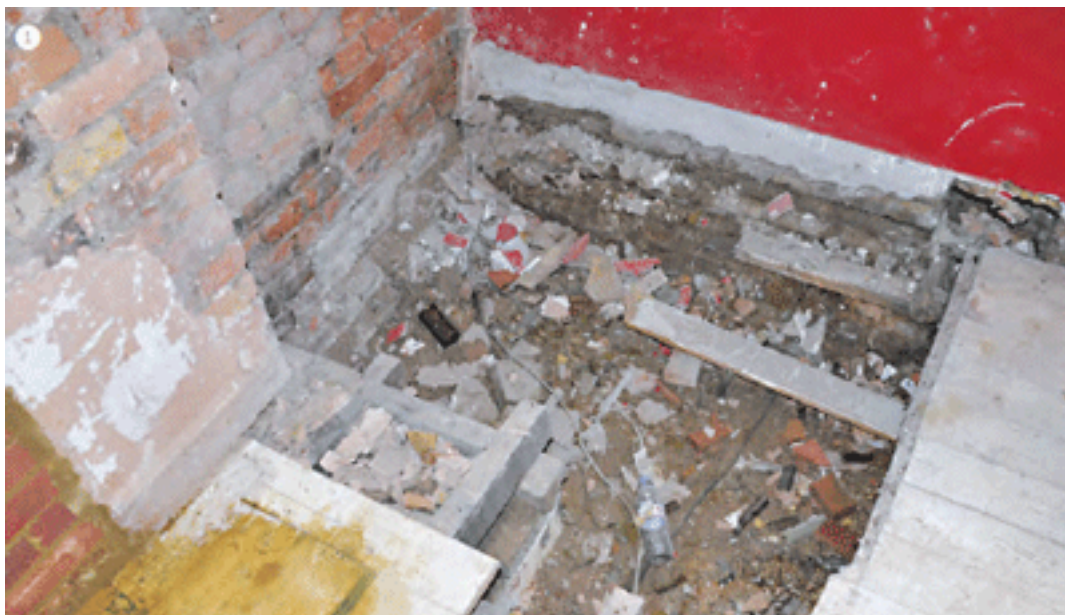
Figure 1: General builder's rubble and arisings placed under the timber suspended floor following property refurbishments

If rubble and arisings are very close to the joists or boards in timber suspended floors, then often dampness will wick through this waste material. This will introduce moisture directly into the timber elements, eventually leading to wet rot (in well-ventilated subfloors) or dry rot (where ventilation has been reduced). This problem can also be caused by blocked external vents. If there are lead water mains under timber suspended floors, any leaks may soak into rubble and arisings, increasing the humidity in the subfloor void.

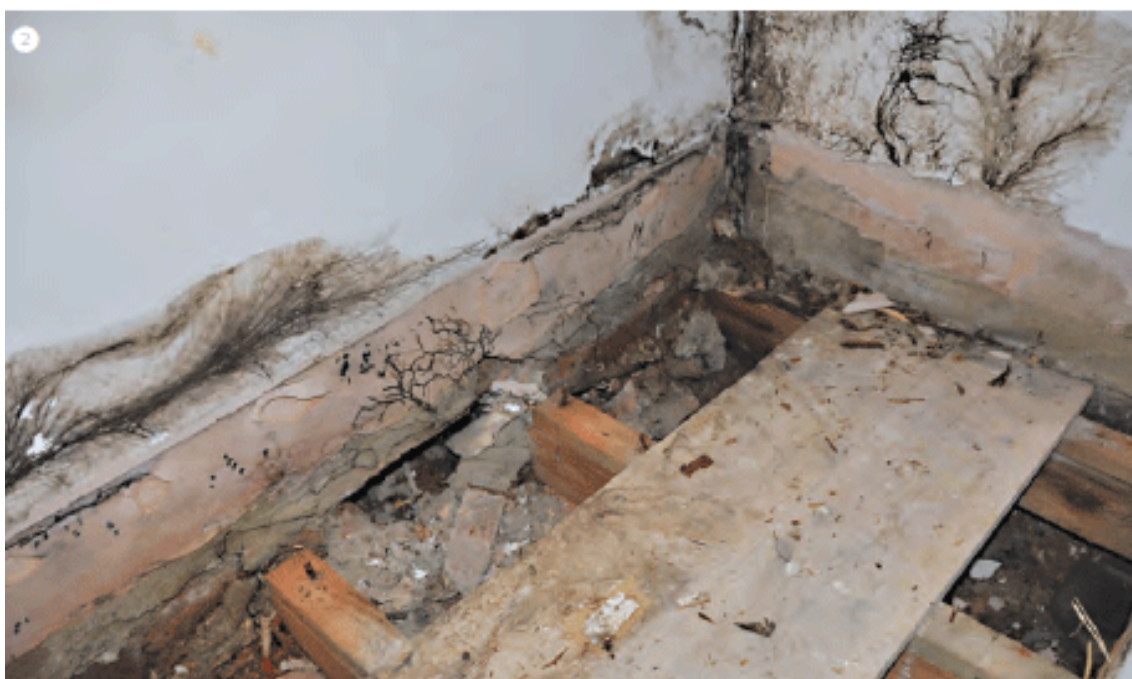
Figure 2: Blocked external low level through-wall vents to the sub-floor. The resultant increased moisture activity led to an outbreak of the dry rot fungus *serpula lacrymans*

and extending *mycelium hyphae* fungus

Where air vents do not exist or are blocked around the perimeter walls, the moisture content of the air below the suspended floor can increase. This crucial issue is often not commented on during surveys.

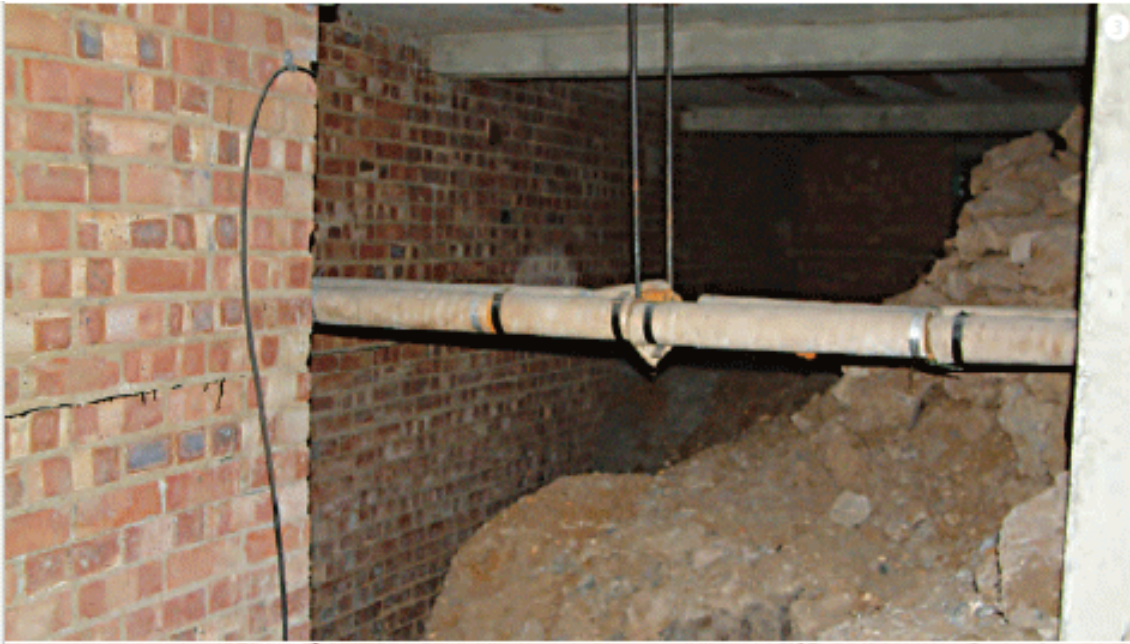
Figure 3: Deep void below a solid suspended floor full of earth and rubble that needed excavation to remove the threat of excessive dampness and resultant condensation. Water droplets were found to the underside of the solid floor, which did not have an impermeable vapour barrier

We surveyed a 1970s, two-storey block of flats in Surrey, with one- and two-bedroom ground and first-floor properties and a communal entrance hall. There was evidence of chronic condensation, i.e. black mould around windows, on external wall surfaces, ceilings, within cupboards and even on partition walls. There were significant amounts of material under the suspended floors that eventually filled three 2.75m skips from below a two-bedroom ground-floor apartment.

A cavernous void underneath the flat was full of material, requiring the whole of the block and beam floor to be removed for access. A hygrometer used on and below the floor indicated a 94% relative humidity at both points, indicating moisture equilibrium.

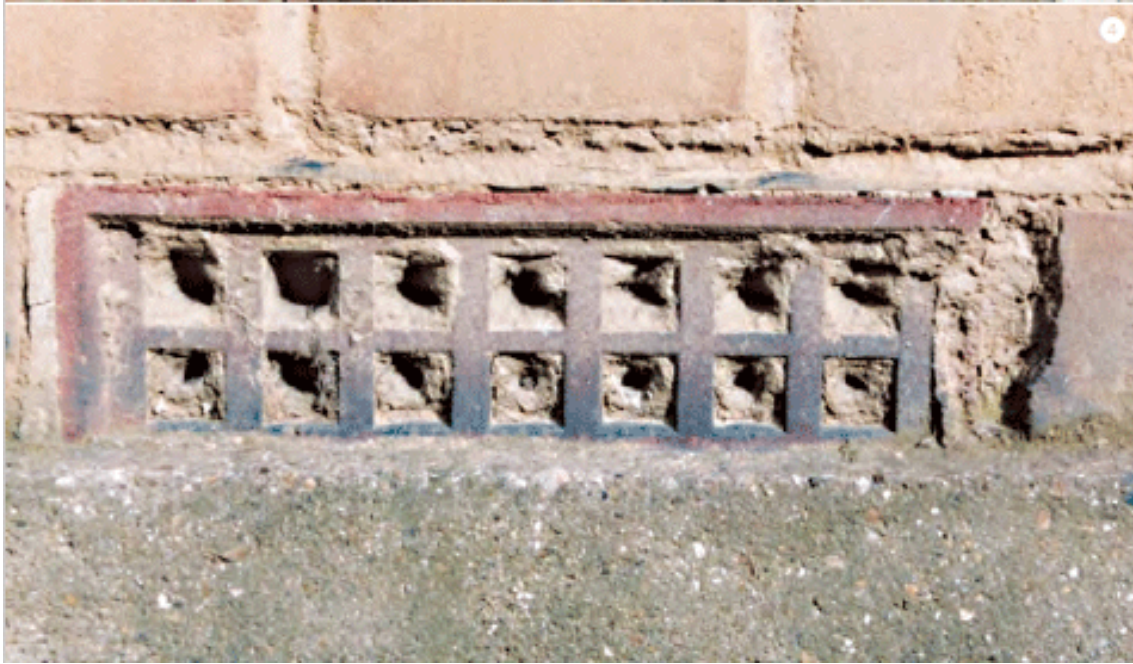
Blocked low level through-wall air vent. The physical damp proof course is just above the vent. The abutting solid concrete patio is in contact with the bottom edge of the vent, sufficient for rainwater to penetrate through the air grill. Rain splash from the hard external surface will introduce dampness into the solid masonry wall above the height of the horizontal damp proof course

The physical horizontal damp proof course in the walls should always be below the internal finished timber or solid suspended floor. Through-wall air vents are typically just below the physical horizontal damp proof course. Of course, if the external ground levels are either partially or fully covering those vents, then the physical horizontal damp proof course could be bridged.

Raised ground levels around air vents can give rainwater an easy route into the subfloor area, especially during heavy rain or flooding. Often, particularly with solid suspended floors, periscopic vents are used where the outside vent grill is higher than the air vent underneath the suspended floor.

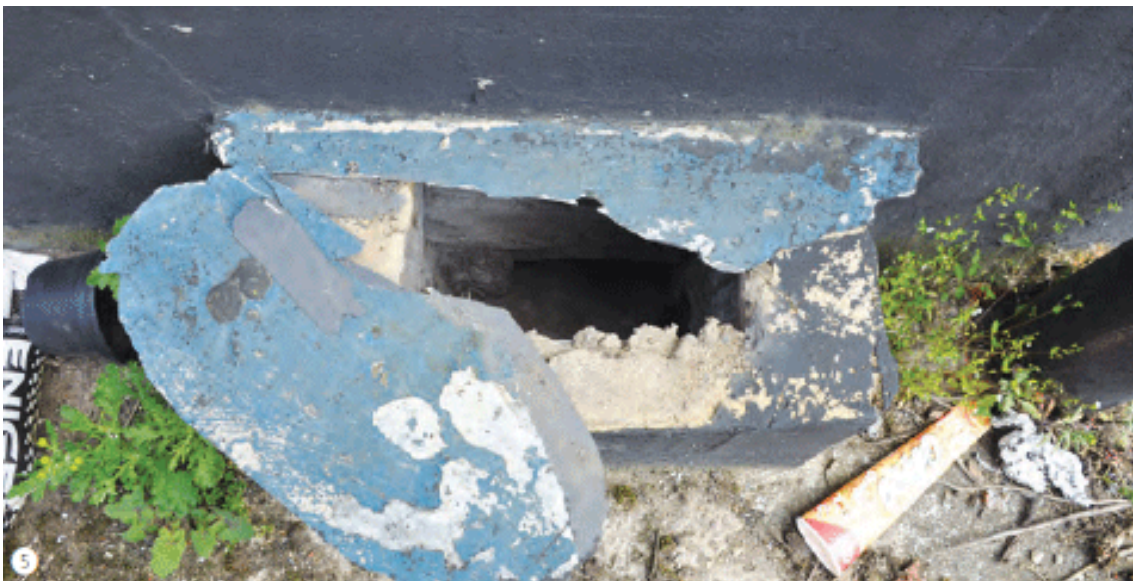
The low level through-wall air vent was shrouded with a half brick thick wall because the external ground level is far too high above the location of the air vent. A slate had been placed over the top of the brickwork to prevent rainwater induction. Another vent to the outer brick created a periscopic ventilation system. The failed slate top resulted in substantial rain water penetration through to the internal suspended timber floor

We have found instances where someone has cut into the solid masonry wall to insert a periscopic vent because it has been difficult to lower the ground levels. This may mean that the original ground level is still bridging the physical horizontal damp proof course. Where those air vents have been chopped into the wall, they may have cut through the physical horizontal damp proof course.

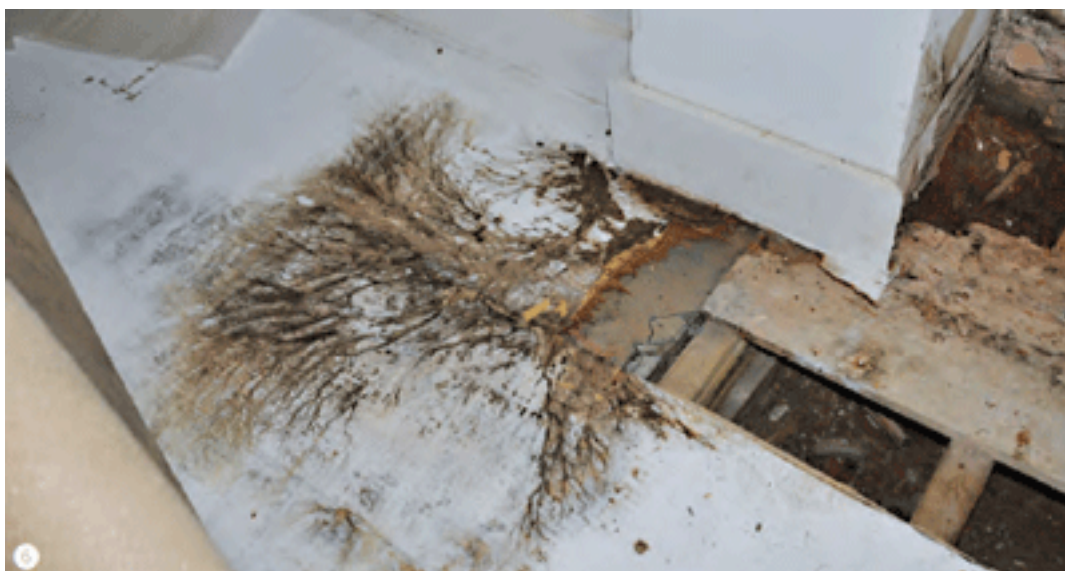
Timber suspended floor and solid fire hearth that had also been over-boarded with timber plywood panels. The dry rot outbreak was due to high abutting ground levels, which had blocked the low level through-wall air vents, and low level dampness penetration through the solid external walls; the sub-floor void was very shallow and a high water table also helped produce the ideal environment

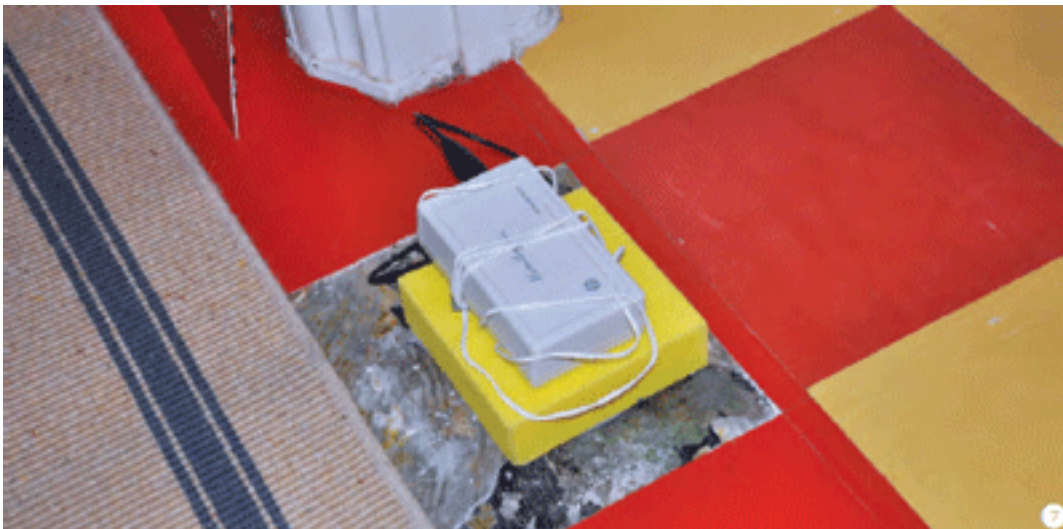
Purpose-made humidity box, sealed to the solid ground supported floor with hygrometer and temperature probe connected to a data capture device to measure the moisture profile of the solid floor (independent of the atmospheric conditions of the habitable rooms)

Often called 'block and beam' suspended solid floors, these are usually constructed of prestressed inverted concrete T beams infilled with concrete blocks and screeded over. These are more difficult to test for moisture than timber, but an easy way is with a hygrometer inserted into a purpose-made humidity box and sealed to the floor. This traps a pocket of air under the box and ideally measurements are taken over 7 days or so to produce a moisture profile.

BS 8203:2009 Code of practice for installation of resilient floor coverings says that the moisture profile emitted from the solid floor should be no higher than 75% relative humidity. Readings above 85%-90% suggest either water leakage into the floor or moisture transfer from the subfloor void due to a lack or failure of a damp proof membrane. A high moisture profile would warrant boring through the solid suspended floor and inserting a hygrometer and temperature probe, leaving this in place for 40-60 minutes to reach moisture equilibrium with the subfloor air.

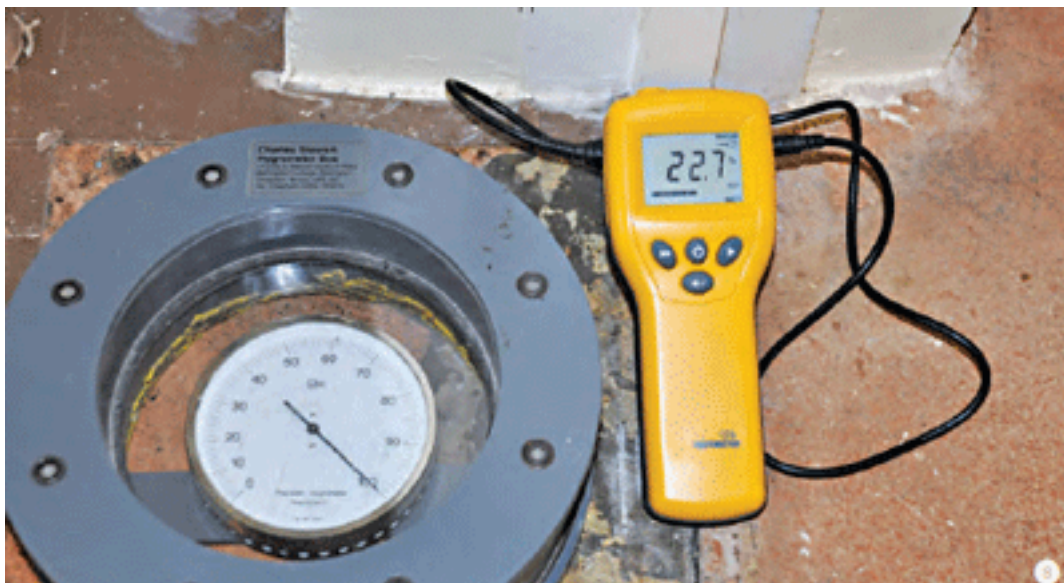
A mechanical hair hygrometer sealed to a solid ground supported solid floor after removing a single thermoplastic floor tile. The hygrometer rapidly recorded 100% relative humidity indicating that the solid floor was damp. This explained the timber damp reading of 22.7% to the bottom of the door lining (above the level at which timber will decay)

An electrical resistance meter can be used to check for moisture activity by measuring the bottom of the timber door linings (unlike skirting boards, they rarely get changed). This would indicate moisture in the subfloor void or the wall to which the door lining is attached. An understairs cupboard can be a good place to view the original timber suspended floor because it may not have any floor coverings. It might even be possible to lift a floor board or drill a hole and view the subfloor void using an endoscope.
